STRUCTURAL & IMPACT PERFORMANCE TEST REPORT

Report No: NCTL-110-10974-1
Test Date: 12/20/08
Report Date: 01/08/08
Expiration Date: 12/31/12

Model Designation: Bovard Studio, Inc.'s Series "Twin Shutter" Aluminum Fixed Shutter.

**1770 SERIES
 LEXAN HURRICANE MODEL**

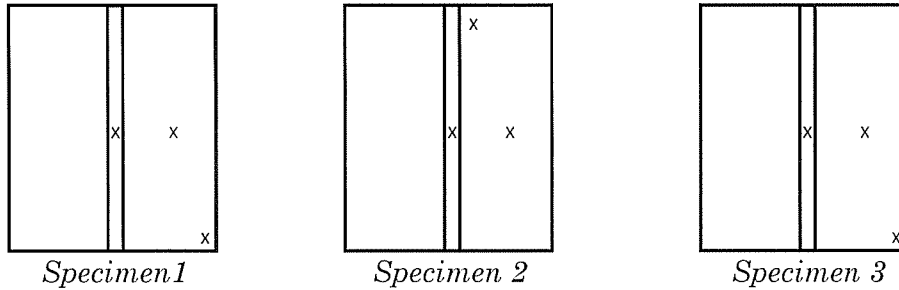
LARGE MISSILE IMPACT TEST

Impact tests were conducted in accordance with TAS 201-94/ PA 201-94.

Type and weight of missile: #2 Southern Yellow Pine 2x4, Length 102" & 9 lbs.

Note: All impacts rejected the missile impacts without allowing penetration.

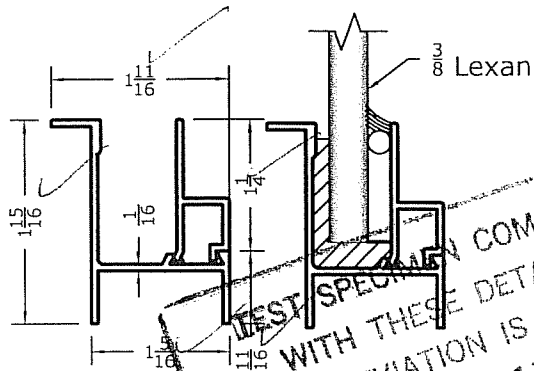
Perimeter Frame

TEST SPECIMEN COMPLIES WITH THESE DETAILS. ANY DEVIATION IS NOTED. REPORT NO. NCTL-110-10741-2.2 TEST DATE 12/07
